Manhole Inspection Summary

Manhole # S29G__023MH

Location Address: **10 s arch st**

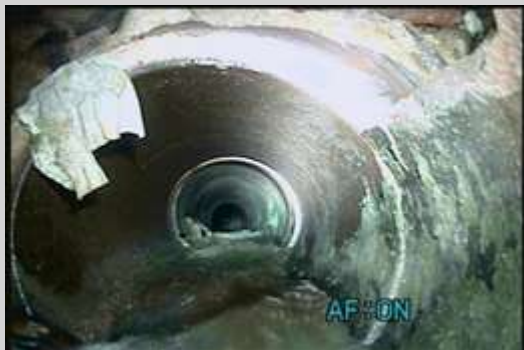
12 O'Clock Outflow

12 in. Circular Gravity Sewer
Pipe Out @ 12 O'Clock

Pipe Material: **Clay** ☐ Pipe Lined

Invert Depth: **10.20** (ft.) Flow Characteristics: **Fast**

Deposits: ☒ None ☐ Mud ☐ Sludge ☐ Debris ☐ Grease

Infiltration: **None** Pipe Seal Cond: **Unknown**

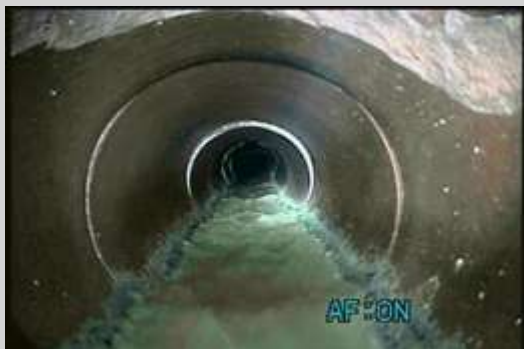
6 O'Clock Inflow

12 in. Circular Gravity Sewer
Pipe In @ 6 O'Clock

Pipe Material: **Clay** ☐ Pipe Lined

Invert Depth: **10.10** (ft.) Flow Characteristics: **Fast**

Deposits: ☒ None ☐ Mud ☐ Sludge ☐ Debris ☐ Grease

Infiltration: **None** Pipe Seal Cond: **Unknown**

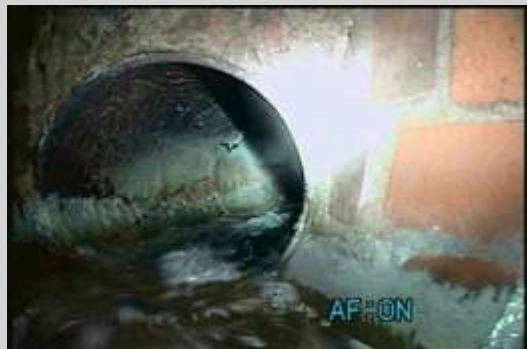
9 O'Clock Inflow

8 in. Circular Gravity Sewer
Pipe In @ 9 O'Clock

Pipe Material: **Clay** ☐ Pipe Lined

Infiltration: **None**
